**DEPARTMENT OF TRANSPORTATION**

Contract #: 04-0120F4Cty: SF/ALA Rte: 80 PM: 13.2/13.9File #: 99.28**WELDING INSPECTION REPORT****Resident Engineer:** Siegenthaler, Peter**Address:** 333 Burma Road**City:** Oakland, CA 94607**Report No:** WIR-018119**Date Inspected:** 08-Nov-2010**Project Name:** SAS Superstructure**OSM Arrival Time:** 700**Prime Contractor:** American Bridge/Fluor Enterprises, a JV**OSM Departure Time:** 1900**Contractor:** Zhenhua Port Machinery Company, Ltd (ZPMC) Chanxing Island**Location:** Shanghai, China**CWI Name:** Mr. Xu Tao**CWI Present:** Yes No**Inspected CWI report:** Yes No N/A**Rod Oven in Use:** Yes No N/A**Electrode to specification:** Yes No N/A**Weld Procedures Followed:** Yes No N/A**Qualified Welders:** Yes No N/A**Verified Joint Fit-up:** Yes No N/A**Approved Drawings:** Yes No N/A**Approved WPS:** Yes No N/A**Delayed / Cancelled:** Yes No N/A**Bridge No:** 34-0006**Component:** OBG Bike Path**Summary of Items Observed:**

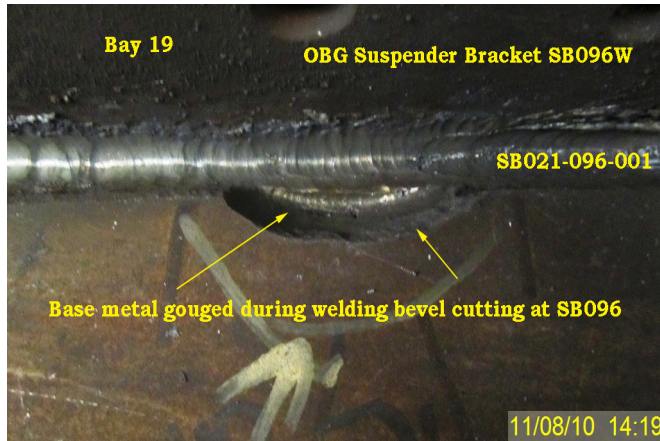
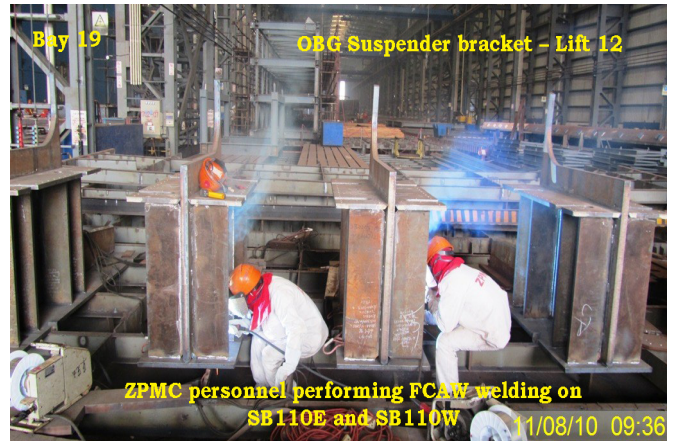
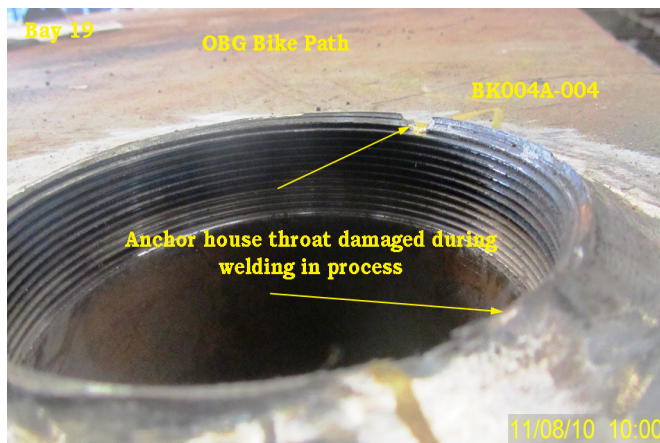
Description of Incident: During random Quality Assurance visual and work in progress of welds located on OBG Bike Path and Suspender Bracket at Bay 19, QA Inspector observed that bike path anchor house pipe throats were damaged while handling material/welding pipe over the deck plate and the damaged anchor pipe fit-up over deck plate. The bike path is identified BK004A-004. The pipe joining weld number is identified as BK004A5-004-084. In suspender bracket, during weld bevel gouging ZPMC personnel damaged base metal. The affected suspender bracket is identified as SB096W. Regarding these issues, this QA inform to ZPMC QC Mr. Xu Tao that take corrective action as per contract documents. See the attached pictures.
